**JACKSON / GILGEN Residence, Silver Lake district,  
Los Angeles, California**

**Restoration of 1960  
modern residence,  
Los Angeles, California;  
original architect:  
Edward Grenzbach**

# RESTORATION PROJECTS • BAKER RESIDENCE

**Rehabilitation 2002 – 2007 for the Ennis House Foundation, Los Angeles, California** The Ennis House, designed by Frank Lloyd Wright in 1924 on a steep slope in the Hollywood Hills, is a building of architectural distinction and historical significance listed on the National Register (#71.10.06.0061) and designated as both a state (#1011) and city (#149) landmark. The house, as well as site walls supporting the motor court suffered substantial damage during the 1994 Northridge earthquake. This \$6,500,000 project provided the stabilization, repair and rehabilitation of the building exterior and site walls that were identified in Damage Survey Reports by the Federal Emergency Management Agency (FEMA) as well as other elements important to the long-term survival of the building. Wiehle-Carr worked in association with Eric Lloyd Wright, grandson of the original architect.

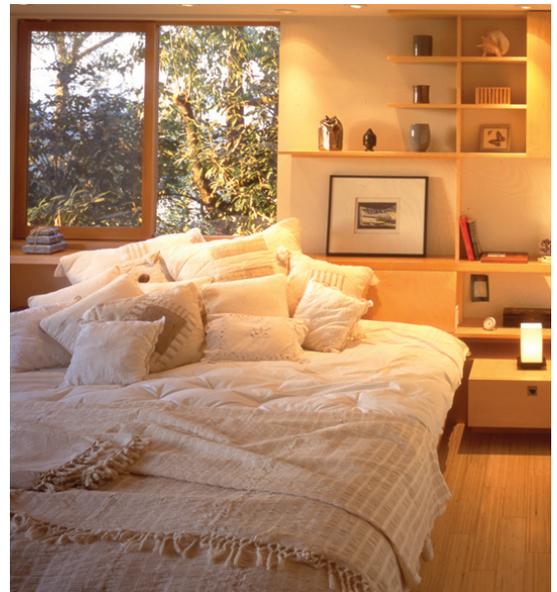
*Clockwise from left below — View into Living room from dining alcove; living room open to dining at left rear; bedroom; view into kitchen from dining alcove; master bathroom with limestone surfaced walls, floor.*  
Photographic images © Sandra Williams

This remodeling of an under 1000 sq. ft. house is a study in how to achieve the perception of spaciousness with very minimal extension of the perimeter. Los Angeles hillside building regulations imposed very strict limitations on expansion to the rear, so the interior space is enhanced by few but crucial partition modifications, redesign of kitchen and bath and incorporation of beautiful and choice woods and stone.

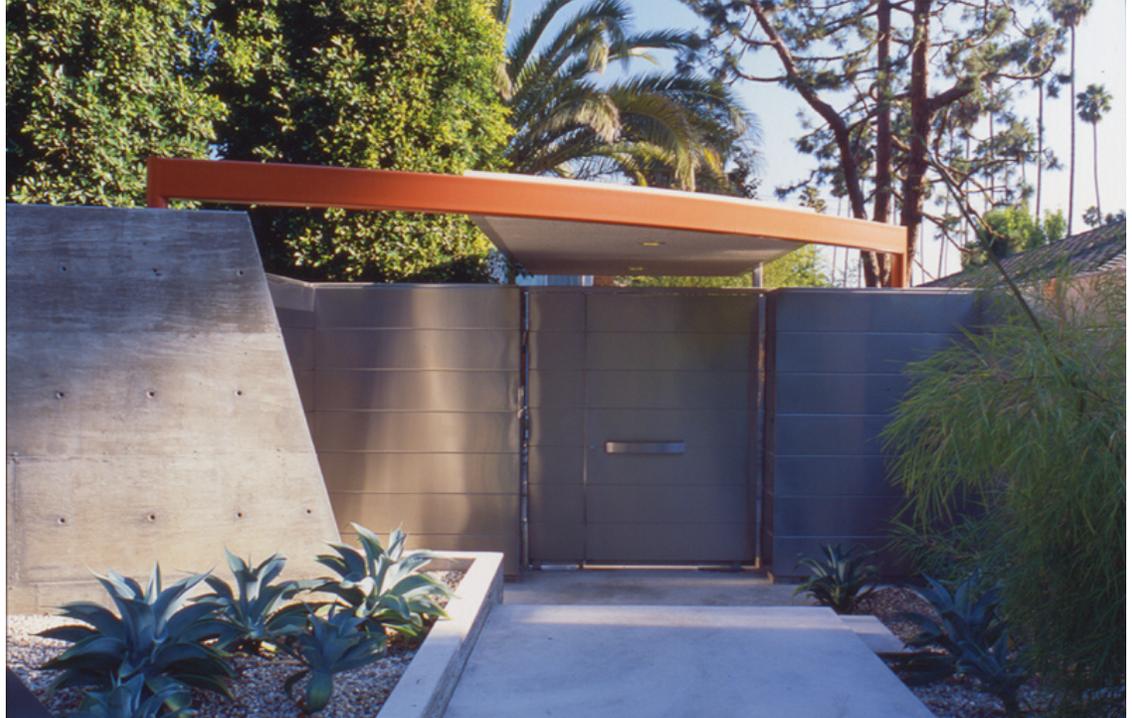
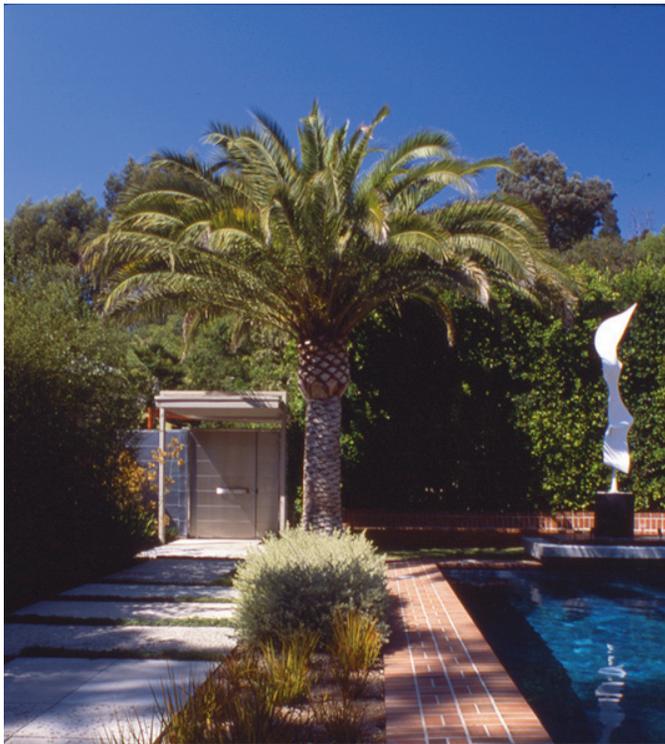
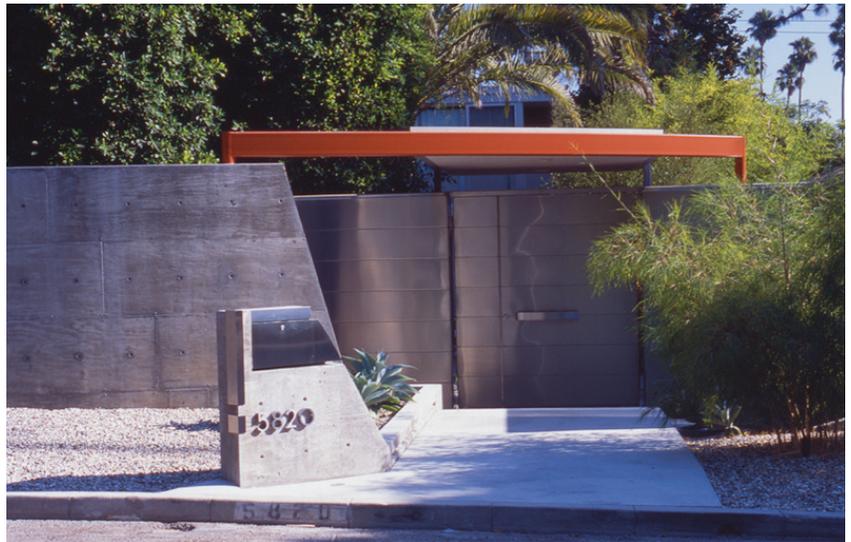
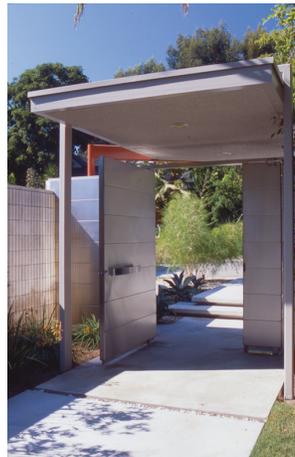
*Clockwise from top — Axial view of stainless steel gate; gate from street view: curvature of concrete wall, continued by red canopy beam above, refers to pool termination within; open gate from garden side; destination view of gate through pool garden.  
All images © Sandra Williams*

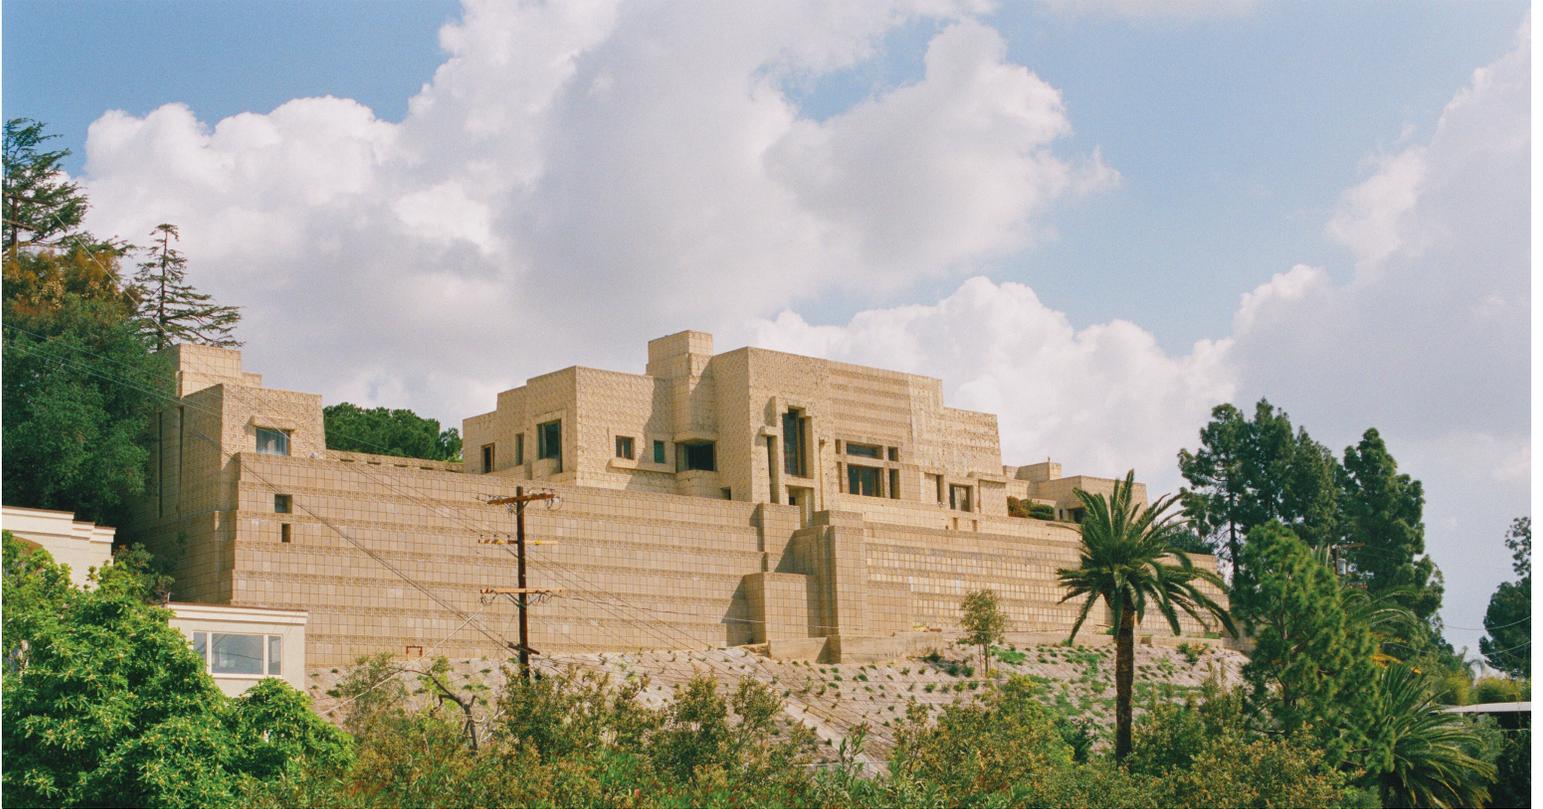
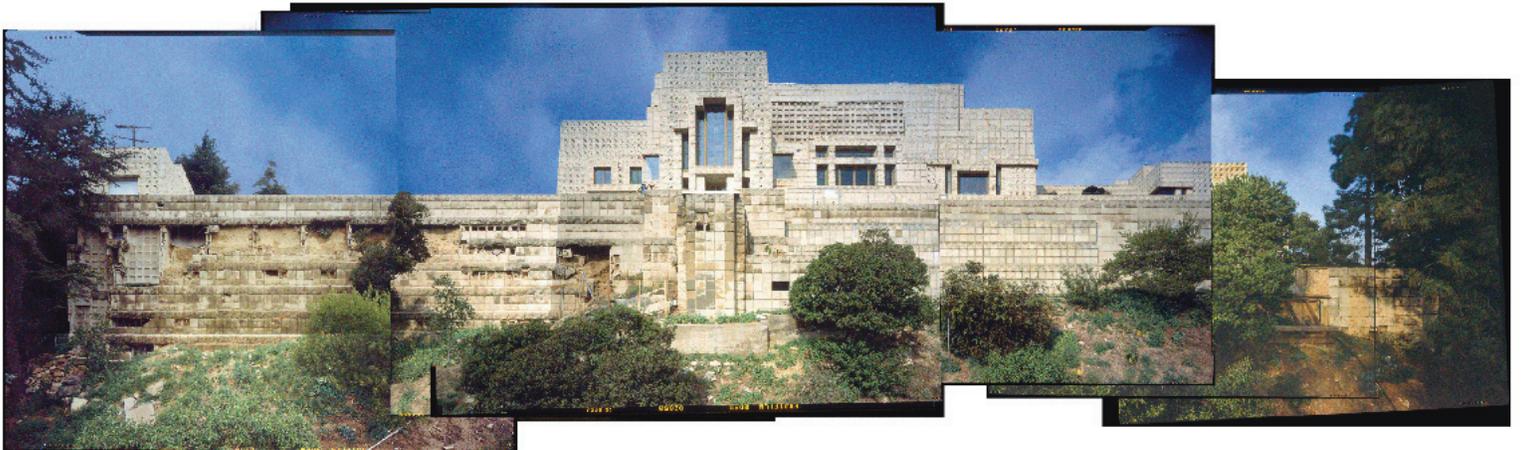
*Top — Restored south elevation of house crowns a massive ridge in the Hollywood Hills;  
Below — South elevation as it appeared before restoration project began.  
Photographic images © Sandra Williams*

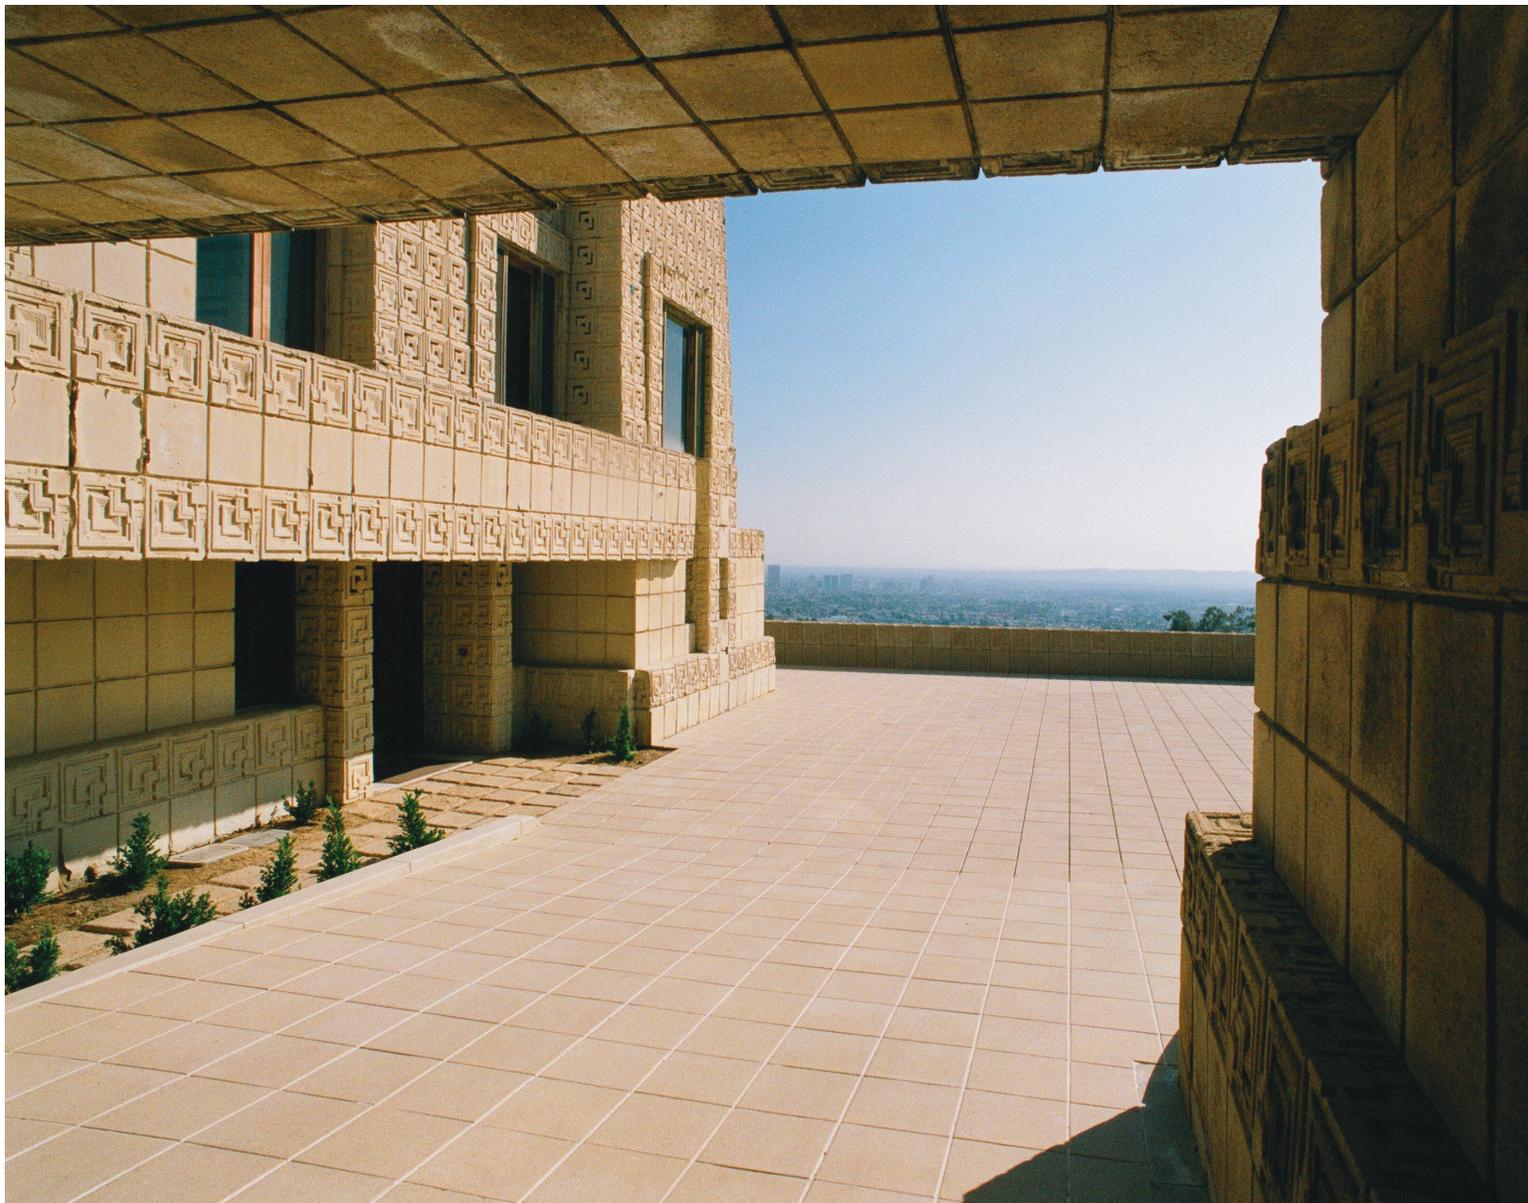
*Entrance driveway opens to completely reconstructed motor court — historically correct pavers supported on massive concrete frame replace 80-year old concrete slab formerly resting on earth. Photographic image © Sandra Williams*

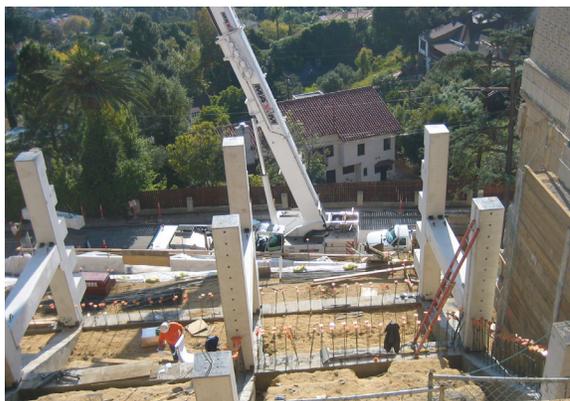
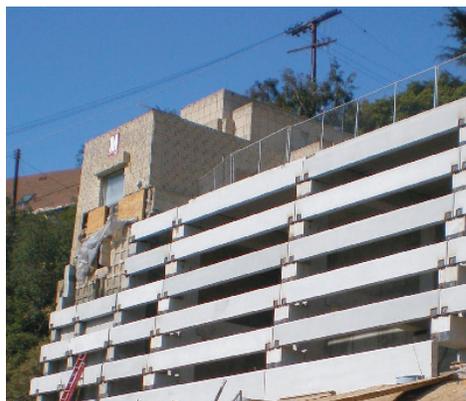
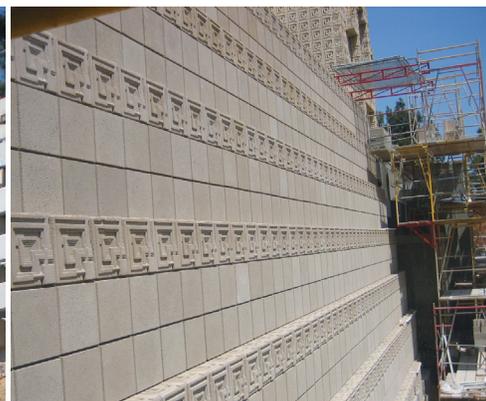
*Left — construction of combination precast and poured-in-place concrete foundation and frame; Center — placement of precast concrete wall beams; Right — construction of concrete "textile block" wall to exactly match original wall that had deteriorated beyond repair. Construction images © Wiehle-Carr*
